REPORT NO. CG-D-125-76

SUMMARY EVALUATION OF THE OFFSHORE
TARGET DETECTION CAPABILITIES OF APS-94D
AND
COR RADAR SYSTEMS

DECEMBER 1976
FINAL REPORT

PREPARED FOR
U.S. DEPARTMENT OF TRANSPORTATION
UNITED STATES COAST GUARD
OFFICE OF RESEARCH AND DEVELOPMENT
WASHINGTON, D.C. 20590

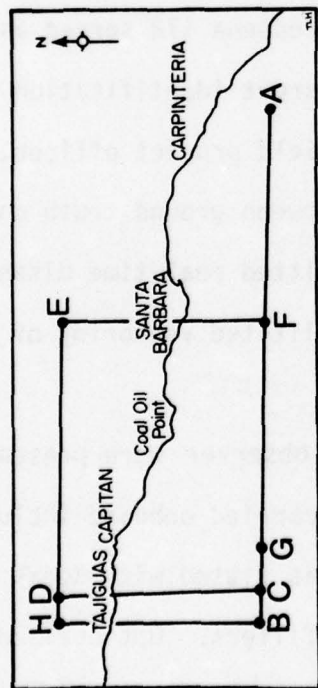
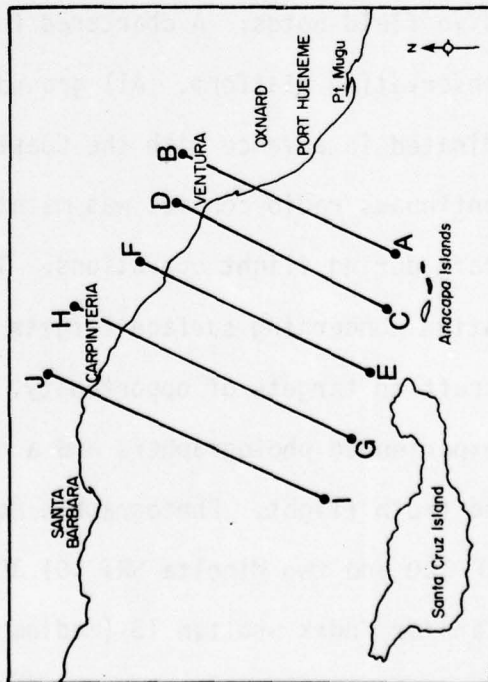
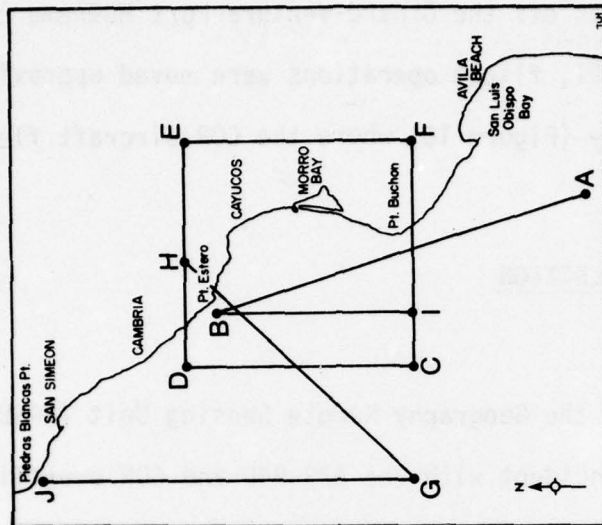
FIGURE 1

APPROXIMATE FLIGHT TRACKS FLOWN BY SENSOR AIRCRAFT DURING THE MAY 19-21, 1976 RADAR TESTS

A. Western Santa Barbara Channel (May 19, 1976).

B. Oxnard-Ventura-Port Hueneme offshore (May 20, 1976).

C. Morro Bay (May 21, 1976).

(Figure 1A). On May 20, the APS-94D was airborne over the eastern Santa Barbara Channel imaging targets off the Oxnard-Ventura-Port Hueneme coastal area (Figure 1B). On May 21, flight operations were moved approximately 150 miles northwest to Morro Bay (Figure 1C) where the COR aircraft flew several radar runs.

* See Figure 1A

* See Figure 1B

* See Figure 1C

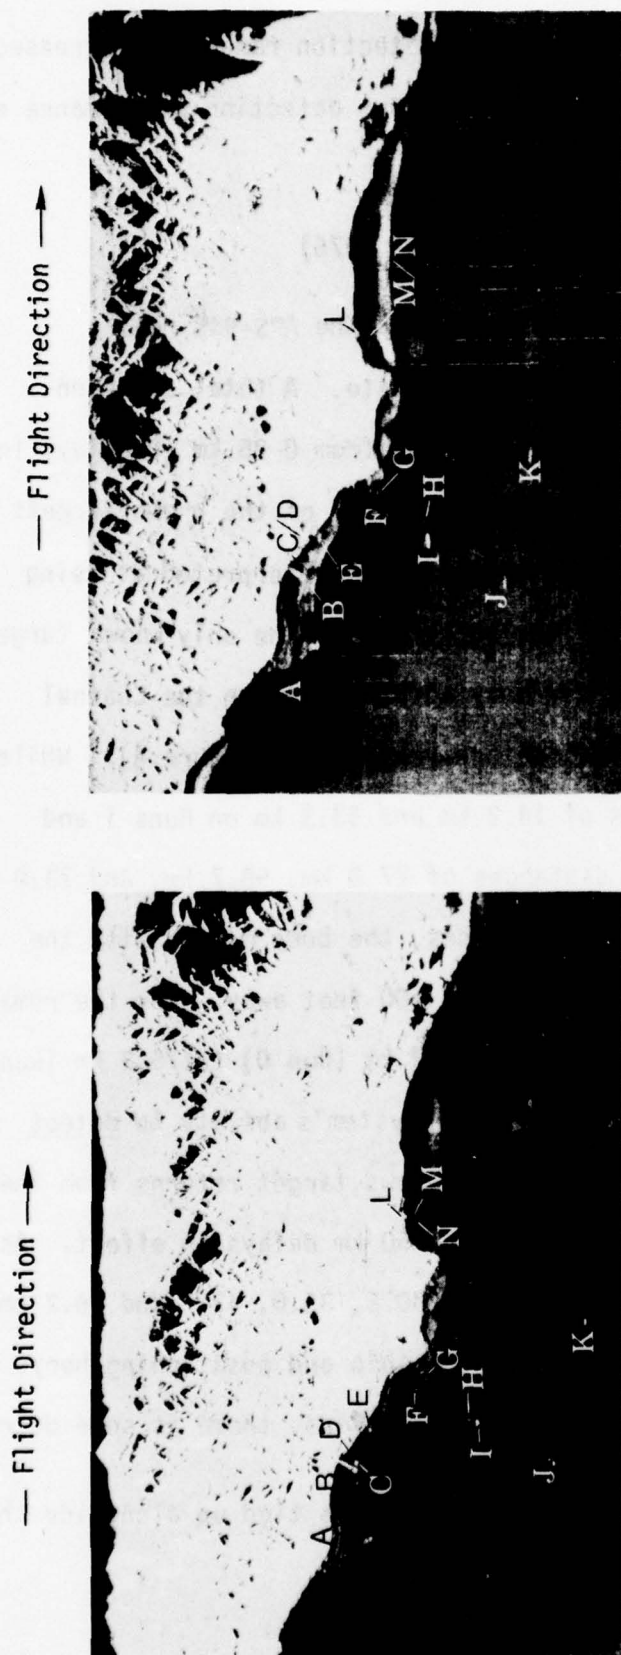
FIGURE 3

APS-94D COR
COMPARISON OF APS-94D AND COR FOR DETECTION OF MAN-MADE TARGETS

Photographs show area of Santa Barbara Channel from Hope Ranch west to Capitan. Imaged concurrently by APS-94D and COR during Run 6, May 19, 1976. Range for both radars was 0-25 km. Operating mode for APS-94D was overland; COR was set for overwater. Known targets include: (A) 35' cabin cruiser off Naples Reef; (B) 2,000' long Elwood oil support pier; (C) 61' aluminum crewboat MALLARD; (D) 83' wooden ocean tug CONTENDER; (E) abandoned concrete and steel pier piling; (F) marker buoy with radar reflector; (G) 5-point tanker mooring at Coal Oil Point; (H) 61' steel crewboat JUNE TIDE underway; (I) oil drilling platform HOLLY; (J) 40' sailboat underway; (K) 83' steel USCGC PT. JUDITH underway; (L) 1,000'Goleta Pier; (M) 25' sailboat; and, (N) 22 x 12' live bait float. Targets not detected by COR located at (A), (F), (M), and (N). Those at (C), (D), and (E) on COR are extremely difficult to differentiate from background return of kelp beds.

(20-45 km swath width) during Run 9, target detection range was increased to more than 40 km. Figure 3 compares the target detection performance of APS-94D and COR during Run 6.

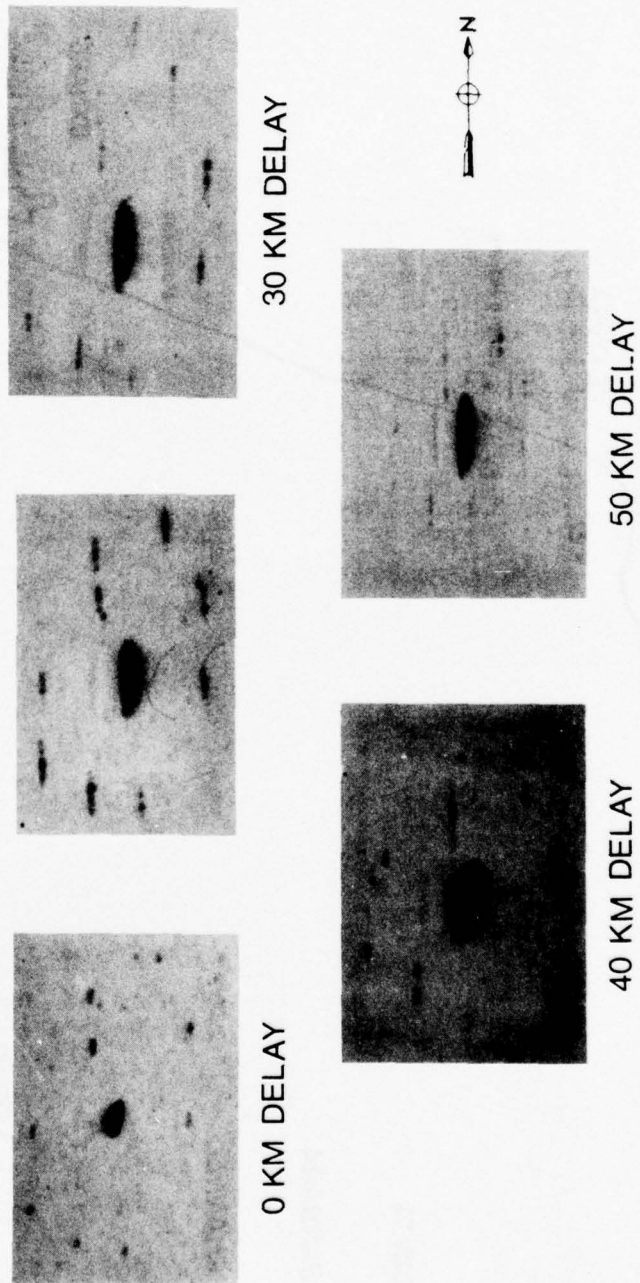
FIGURE 5

RANGE DETECTION OF OIL DRILLING VESSEL CUSS I
AND MOORING BUOY PATTERN ON APS - 94D IMAGERY
MAY 20, 1976

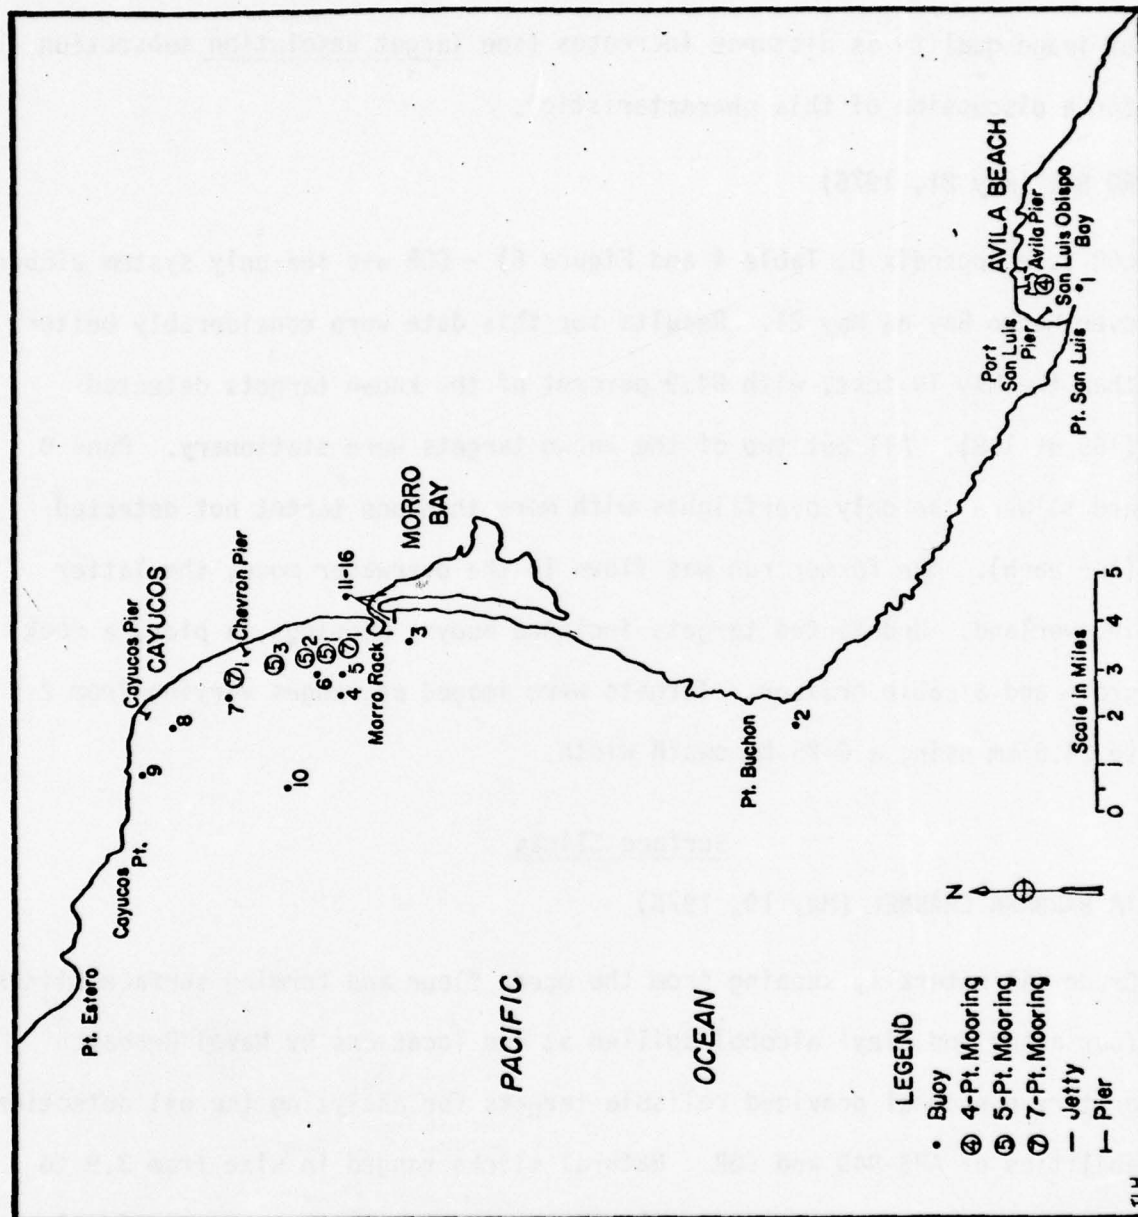
FIGURE 6

MORRO BAY TEST AREA

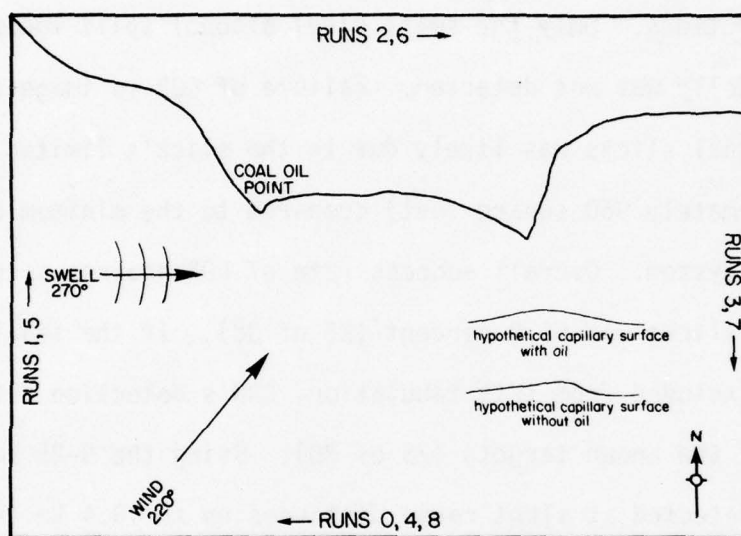
FIGURE 7

Sketch map depicting approximate wind and swell directions in the western Santa Barbara Channel, May 19, 1976. Look direction from APS-94D and COR perpendicular and to the right of the aircraft flight direction for each run.

good backscattering compared to oil covered areas where a dampening or flattening effect on capillary waves reduces surface returns (see sketch map Figure 7).

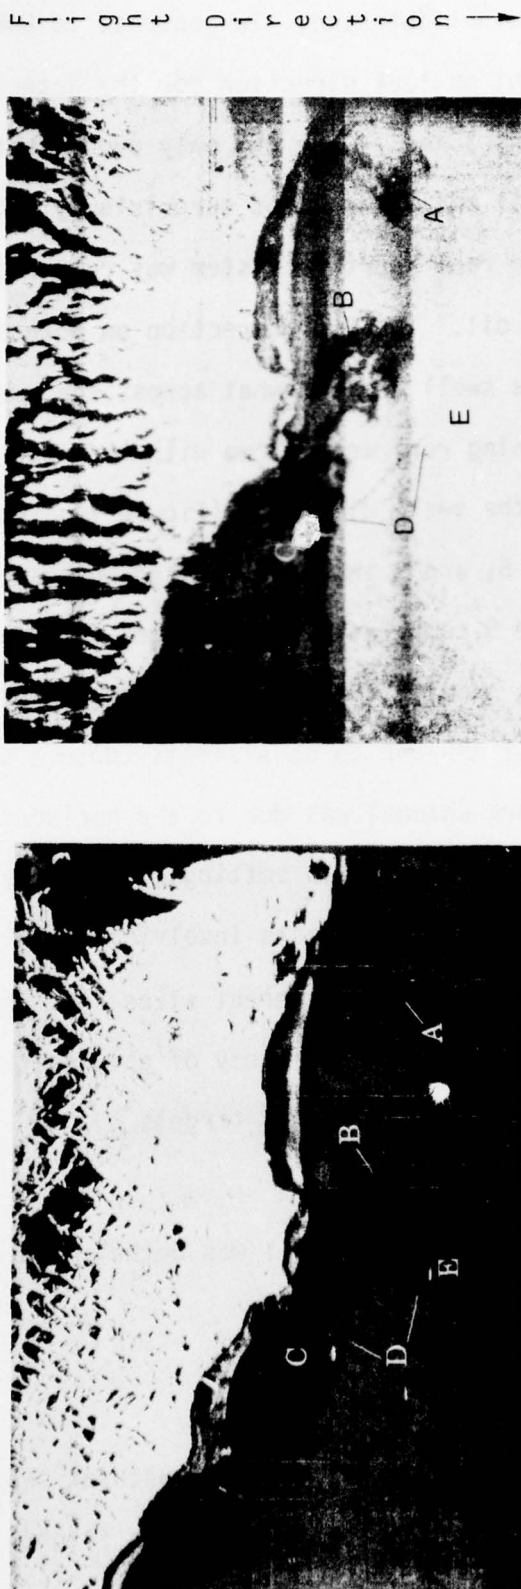
FIGURE 8

— Flight Direction —→

Run 6

Run 7

- COR (see Appendix B, Table 2) - the COR consistently detected surface slicks associated with natural oil seepage and the long oleyl alcohol spill from all look directions. Only the small oleyl alcohol spill located southwest of platform Holly was not detected. Failure of COR to image the smaller of the two artificial slicks was likely due to the slick's limited surface area (i.e. approximately 960 square feet) compared to the minimum cell size resolution of the system. Overall success rate of COR against actual and simulated surface slicks was 65.8 percent (25 of 38). If the small oleyl alcohol spill is excluded from this tabulation, COR's detection rate increases to 83.3 percent of the known targets (25 of 30). Using the 0-25 km range setting, oil was detected at slant range distances up to 18.4 km from the sensor aircraft. With a 20 km delay (20-45 km range setting) in effect, the maximum slant range distance at which oil was imaged was 26.1 km. With the exception of Run 4, the vertically polarized COR synthetic aperture system provided excellent contrast between both the detectable natural and artificial surface slicks and the ocean surface. Figure 8 illustrates the oil detection capability of COR using imagery from Runs 6 and 7.

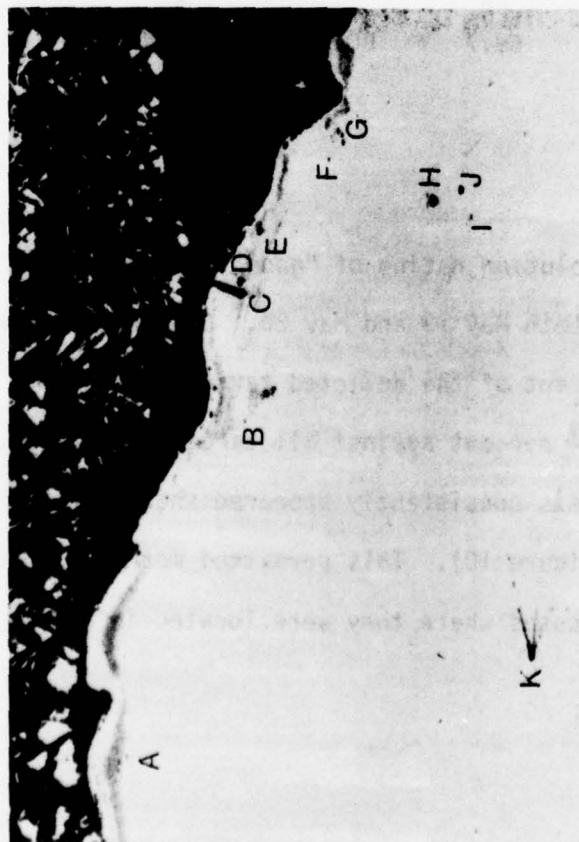
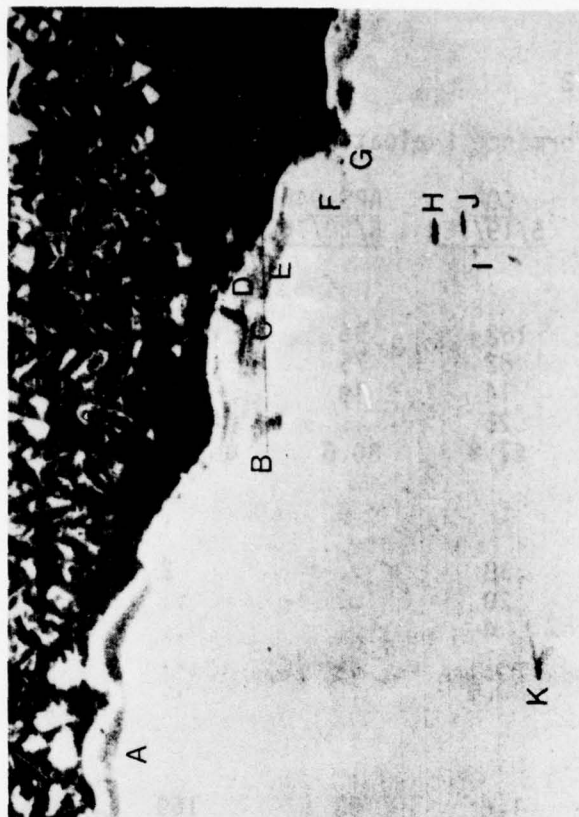
FIGURE 10

APS-94D

COMPARISON OF TARGET RESOLUTION PERFORMANCE: APS-94D AND COR (May 19, 1976)

COR

Photographs show the offshore area from Coal Oil Point west to Capitan. Imaged by APS-94D (left) and COR (right) during Run 2 of the May 19, 1976 coincident overflights. Range for both radars 0-25 km. APS-94D operating in the overland mode; COR is the overwater mode. Targets include: (A) 5-point tanker mooring off Capitan; (B) small cabin cruiser (235'); (C) 2,000' Elwood Pier; (D) 83' wooden ocean tug CONTENDER and 61' aluminum oil crewboat MALLARD anchored 30-40 meters apart; (E) abandoned concrete pier pilings; (F) marker buoy with radar reflector; (G) 5-point tanker mooring off Coal Oil Pt. with small center buoy; (H) oil drilling platform HOLLY; (I) 16 sq. ft. plastic and wooden float with radar reflector; (J) 83' USCG Cutter PT. JUDITH; and, (K) 75' wooden ocean tug underway. Note the sharpness and clarity of targets on the APS-94D compared to COR. Several targets detected by APS-94D not recorded by COR (A and F); others tend to blend into background on the latter (B, D, E, and G), making detection more difficult for the image analyst.

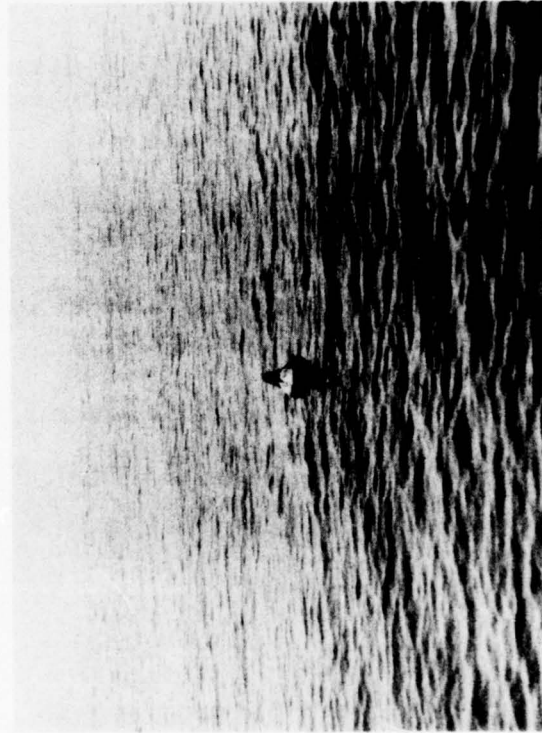
Small marker buoy with radar corner reflectors.
Located west of the Burmah Oil 5-point tanker
mooring off Coal Oil Point. Photographed
June 17, 1976

Navigation buoy located near the entrance
to Santa Barbara Harbor. The steel construc-
tion buoy is equipped with radar corner
reflectors. Photographed June 17, 1976.

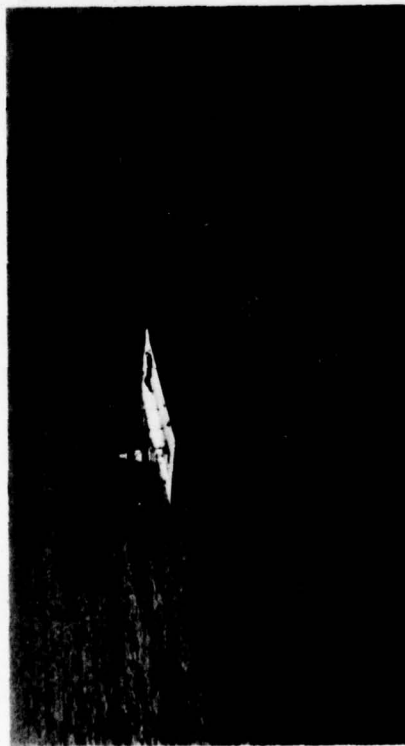
Top left- Metal positioning float with radar reflector. One of eight temporary floats anchored SW of Capitan to mark the location of a new Exxon oil drilling platform. Photographed June 17, 1976.

Top right- Live bait float anchored off Goleta Pier. Float is of wood construction with steel reinforcement along the sides. Photographed June 17, 1976.

Bottom left- Small wood and plastic float with radar reflector. Used by the Coast Guard as a calibration target off Platform Holly on May 19 and Channel Islands Harbor on May 20. Photographed May 20, 1976.

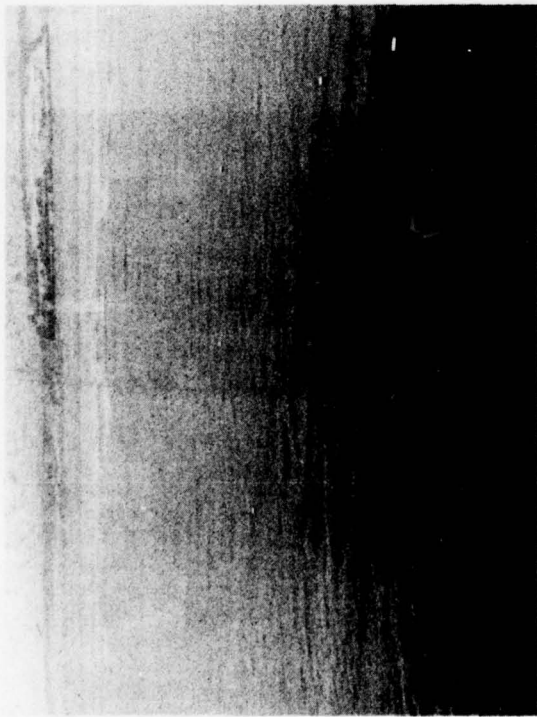
Seven point tanker mooring located NW of Morro Rock. Metal floats are spaced approximately 100-150 feet apart. Photographed May 21, 1976 under low clouds.

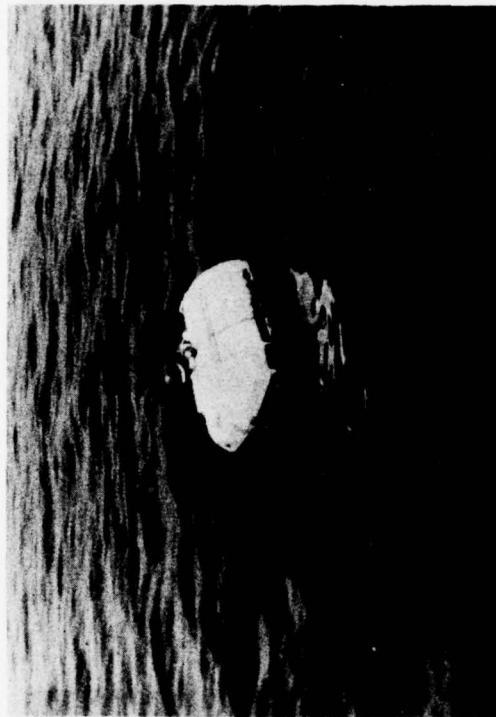
Close up view of individual mooring float within 5-point tanker mooring off Coal Oil Point. Photographed June 17, 1976.

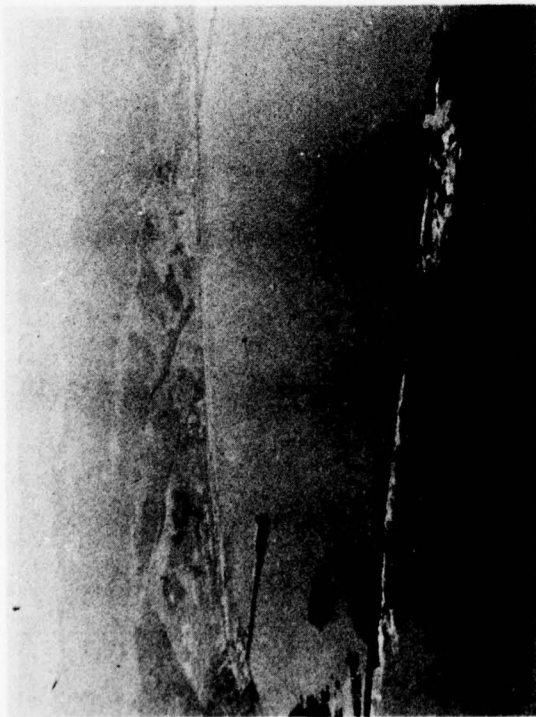
Top left- Rock groin off Point San Luis. Piers in background are Port San Luis Pier (left) and an oil support pier (right). Note large number of small boats anchored in San Luis Obispo Bay. These were not detected by COR.

Bottom right- Work area of oil support pier located NW of Avila Beach. Note mooring floats on either side of pier causeway.

All photographs taken May 21 under a 1,500 foot cloud base.

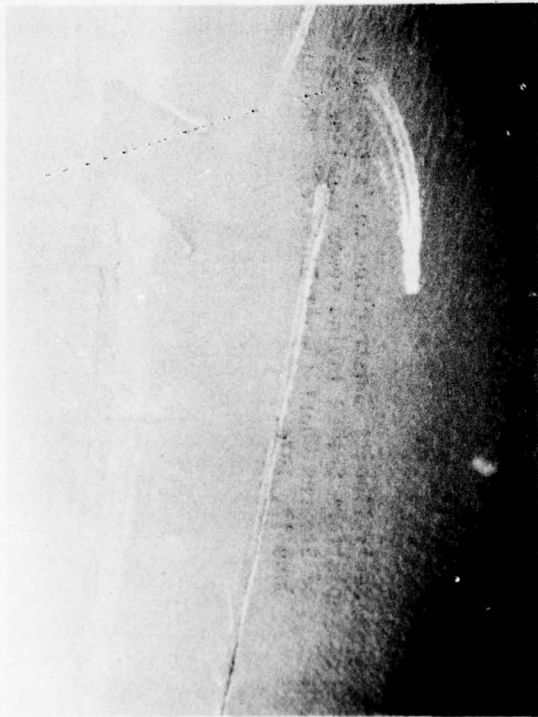
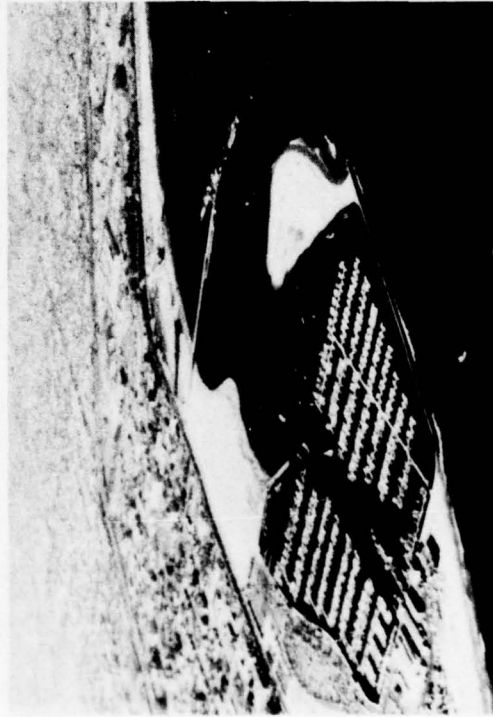
Top left- Channel Islands Harbor and breakwater.
Photographed in extremely hazy conditions
May 20, 1976.

Top right- Rock groin at the entrance to Hueneme
Harbor. Photographed May 20, 1976.

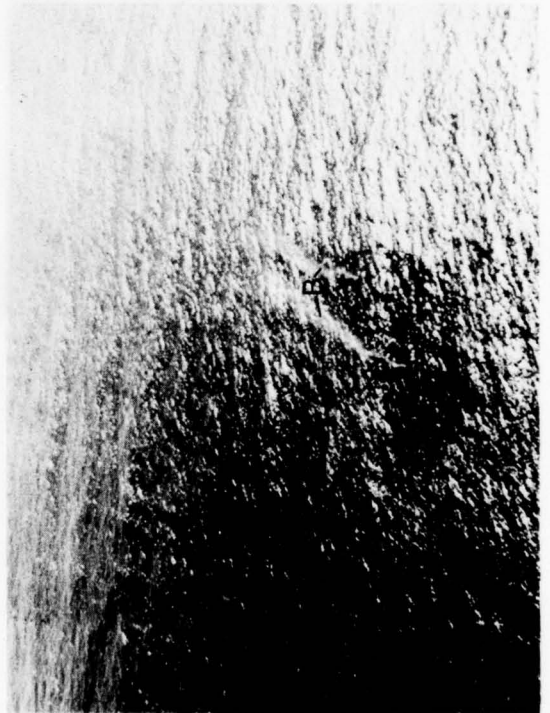
Top left- Cutter PT. JUDITH (A) dumping oily alcohol (B) off Platform HOLLY (C). Photo taken May 19, 1976. Note large area of natural oil seepage (D) visible through the haze.

Top right- Broadside view of PT. JUDITH releasing oily alcohol over the stern.

Bottom right- Small oily alcohol spill (A) with marker dye (B). Maximum area of the slick was approximately 100 feet x 60 feet. Slick was not observed on APS-94D or COR.

All photographs taken May 19, 1976.

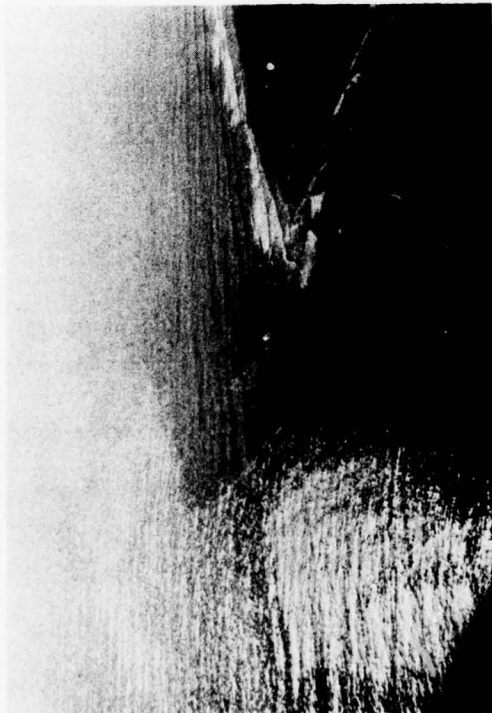
Seep oil surfacing just east of Coal Oil Point.
Photographed May 19, 1976.

Natural oil seeps off Coal Oil Point. Sun
glitter marks area of heavy surface concentra-
tion. Photographed May 19, 1976.

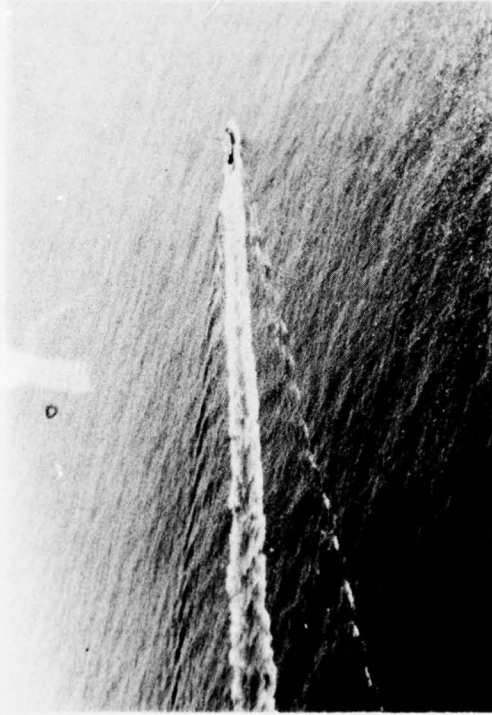
Wooden-hulled ocean tug underway southwest of Platform HOLLY. Unidentified vessel is approximately 75 feet long. Photographed May 19, 1976.

120 foot sand barge anchored off Santa Barbara. Note the sewer pipelaying platform in the background. Photographed June 17, 1976.

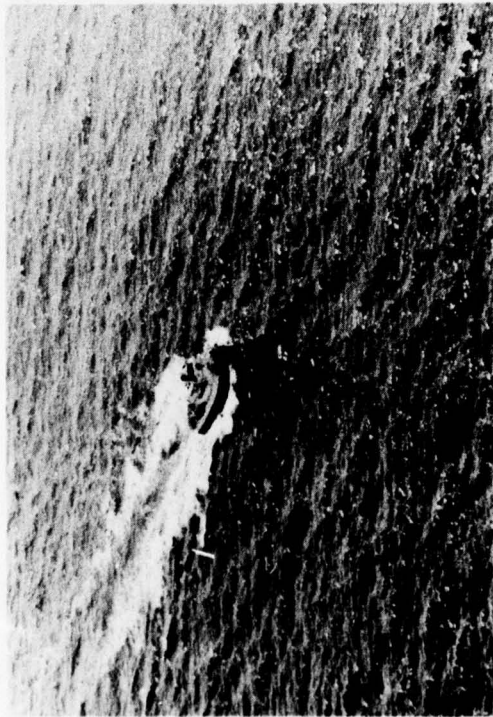
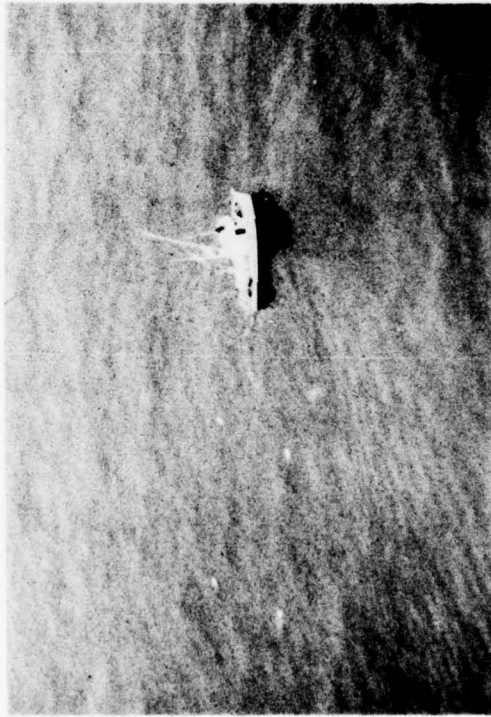
Top left- 65 foot sport fishing boat ESTRELLA returning to Channel Islands Harbor. Photographed May 20, 1976.

Top right- 95 foot Coast Guard cutter CAPE HEDGE dumping oily alcohol in calm seas off Morro Rock. Photographed May 21, 1976.

Research Laboratory personnel released quantities of oleyl alcohol from the USCG Cutter CAPE HEDGE, no oil was conclusively detected on COR Runs 8-17. Surface conditions were smooth with wind velocity estimated at four knots (maximum) and swell height at one foot. It is probable that the lack of contrast between oil and non-oil areas resulted in COR's inability to detect surface slicks.
